The Use of Geofibers and Synthetic Fluids Kwigillingok Airport

FINAL REPORT

Report # RR08.14

February 2011

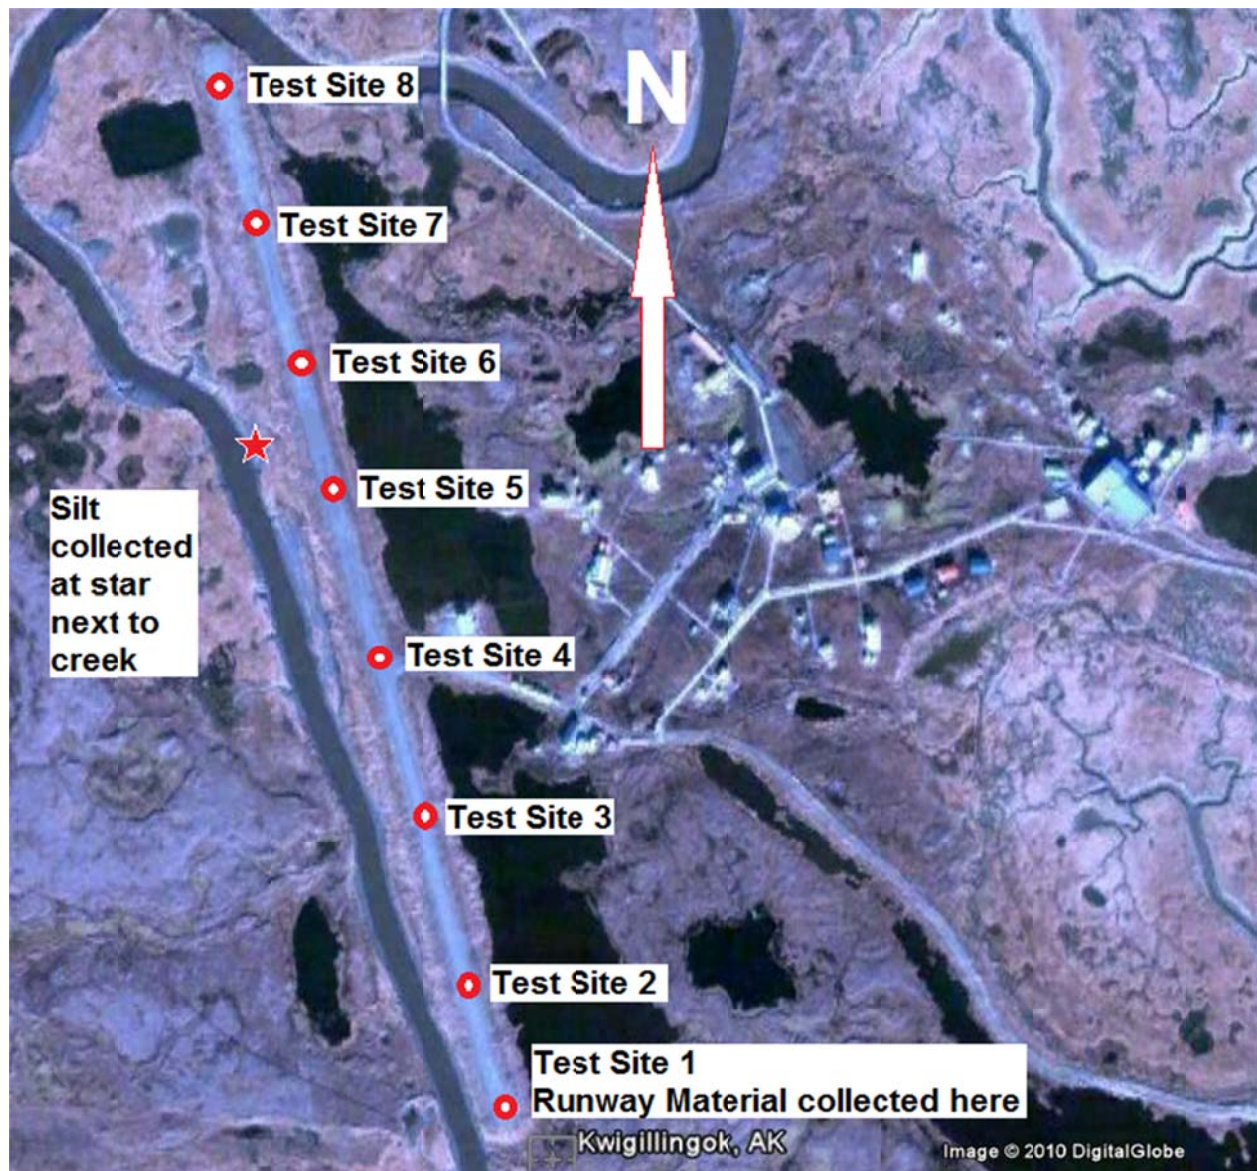
Figure 6: Map of Kwigillingok runway with points of interest marked

Stiffness measurements were taken at eight locations along the runway. The Geogauge measures to a depth of nine inches. The first measurement was taken on the south end and readings were taken at nearly even distances to the north end of the runway. At least two measurements were taken in each location. In a few locations, three were taken because the first two did not agree with each other. A table summarizing the results of the Geogauge testing is presented as [Table 1](#). An aerial photo of the Kwigillingok runway is shown as [Fig.6](#) shows the test locations.

Material was needed for use in laboratory testing. This will be treated with geofibers and synthetic fluid in an attempt to improve the strength and stability of the soil. The material collected is clay from the riverbank. This is representative of the soil found throughout Kwigillingok. A picture showing the site the clay was collected from is presented as [Fig.7](#). The site is also indicated by a star on [Fig.6](#).

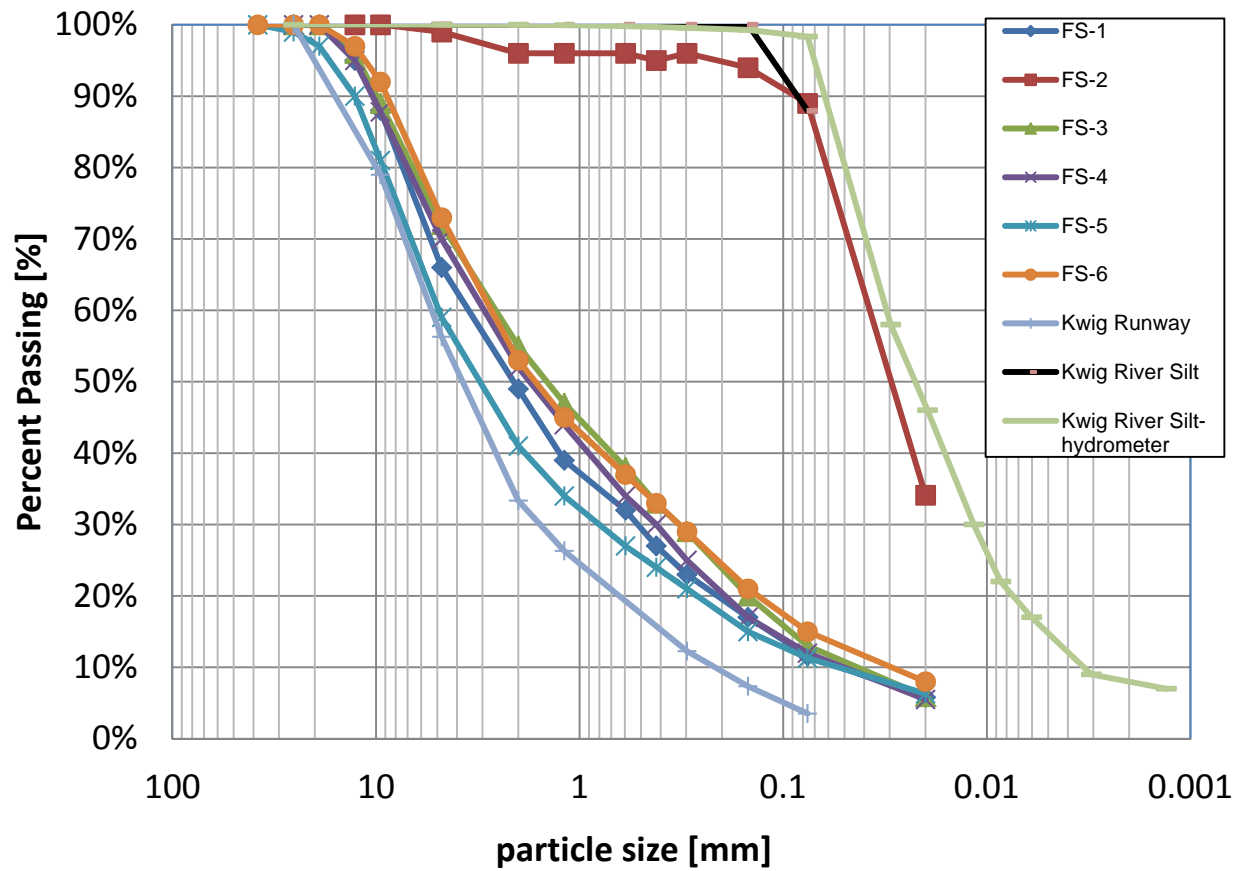
The gravel material found on the runway, and the clay material underlying Kwigillingok was compared with sieve analysis results provided by AKDOT [Fig.8](#). The uniformity coefficient (C_u) and the coefficient of curvature (C_c) is 70.8 and 2.2 for the gravel material and 9.7 and 1.3 for the clay material. The gravel is classified as well graded gravel (GW) according to the United Soil Classification System (USCS).

Figure 8: Particle Size Analysis of Kwigillingok Soil

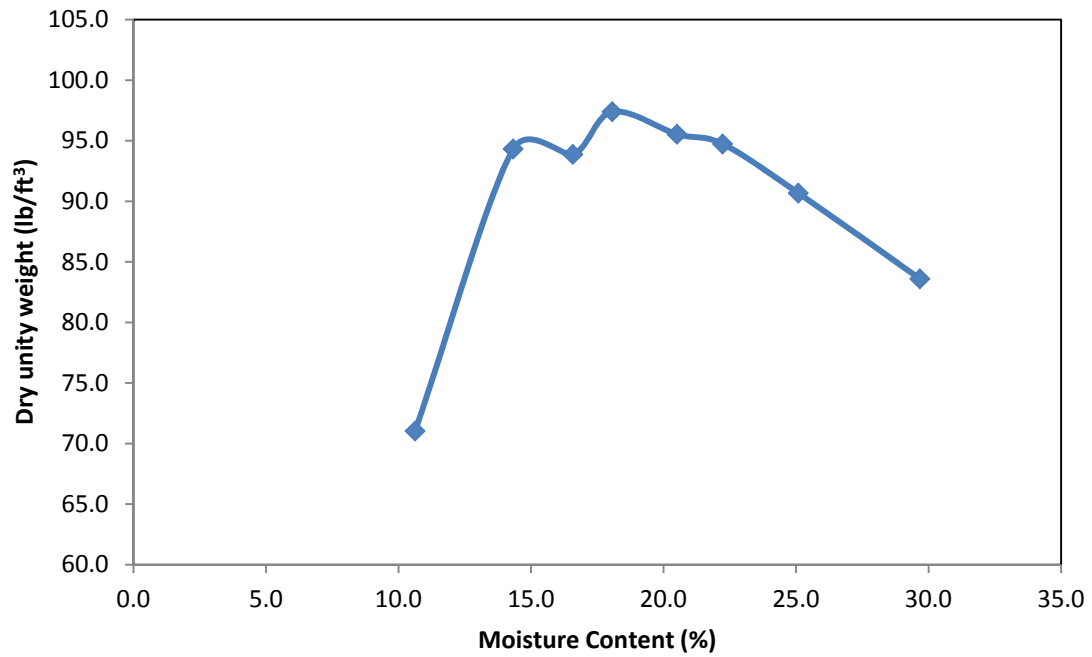
The maximum dry density curve was found using mechanical compaction. The optimum moisture content of the Kwigillingok soil is 18% with a maximum dry density of 97.4 lb/ft³. The moisture density curve is presented as [Fig.9](#).

Figure 9: Moisture Density curve for Kwigillingok Clay
